Improving Intervention Efficiency with Downhole X-ray Diagnostics

by Melissa Spannuth, PhD, Senior Physicist, Visuray

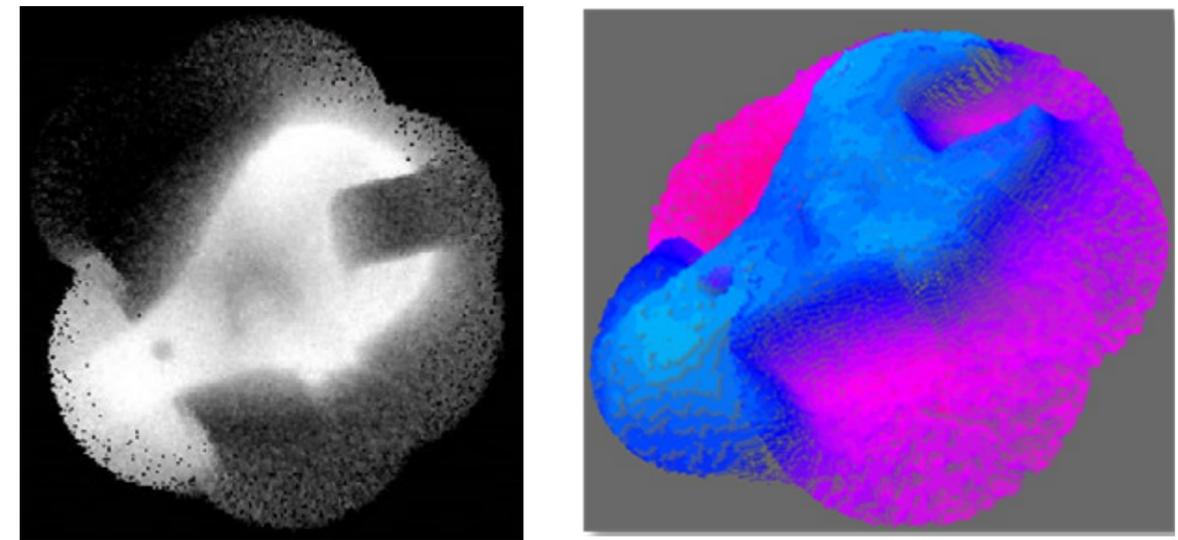
Figure 1. Examples of 2d depth map (left) and 3d rendering (right) from laboratory imaging of an adjustable spanner

An example of one such reconstruction is shown in Figure 1 where it is displayed both as a two-dimensional depth map image and a three-dimensional rendering. In the depth map representation, white and light grey pixels represent areas that are closer to the VR90 tool, while black and dark grey pixels represent areas that are farther from the tool (i.e. the depth of the surface of the object is mapped to a grey scale color scheme). The imaging data were obtained during laboratory tests in water made completely opaque by particles of rust suspended in it. The results reveal an easily recognizable adjustable spanner. Fine details on the spanner are visible, such as a small hole in the neck and the threads on the adjustment screw, demonstrating the millimeter-scale resolution of the VR90 tool’s reconstructions. Furthermore, these reconstructions are dimensionally-accurate, so the resulting images and renderings can be used to measure features on the target object with millimeter-scale accuracy. While these results were obtained in the lab, the VR90 service reliably produces the same caliber results in the field – all in real-time without any well preparation necessary.

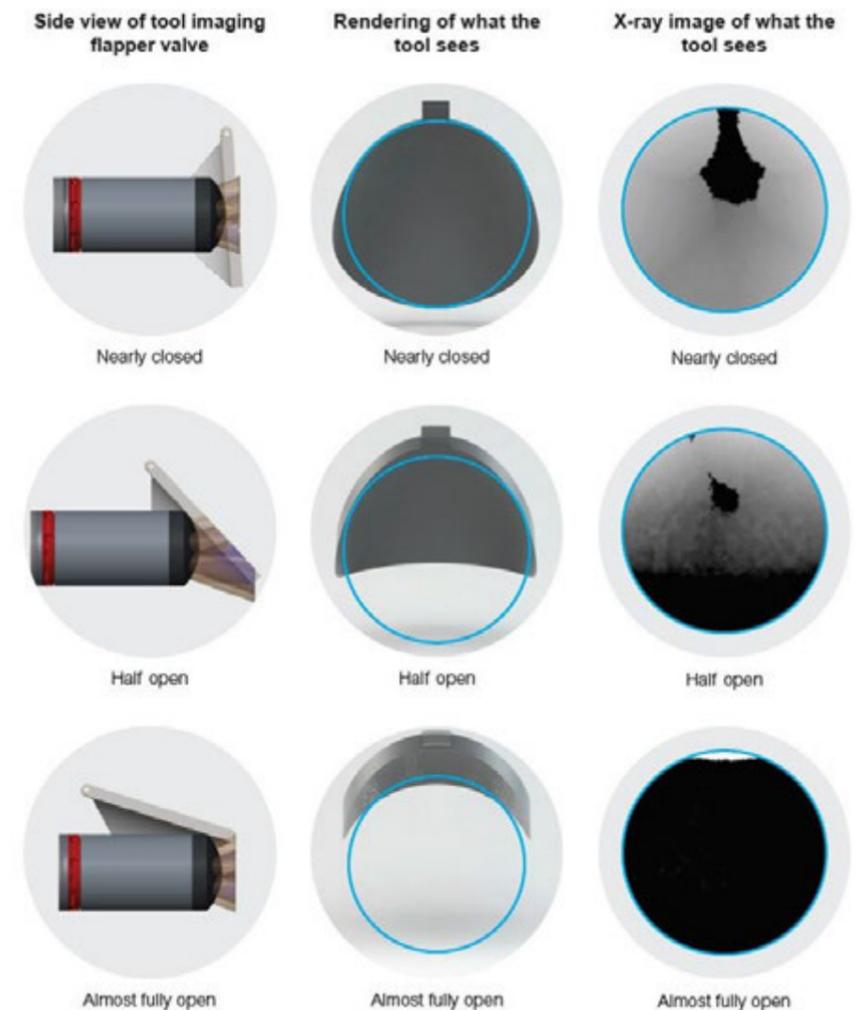
Figure 2. Results of VR90 service’s X-ray investigation of DHSV in a North Sea well

We achieved these objectives by acquiring multiple X-ray images with the VR90 tool positioned at various locations within the DHSV. Three of the X-ray images acquired by the VR90 tool are shown in Figure 2. Side view drawings of the corresponding tool and flapper positions, and renderings of what the tool sees are also shown. From top to bottom, the X-ray images show the flapper nearly closed, half-way closed, and almost fully open. As indicated by the drawings, the VR90 tool was resting on the flapper and pushed it open as the tool was moved through the valve. The X-ray images show that the maximum measured opening angle of the flapper was 73°.

In particular, the VR90 diagnostic service provided two key pieces of information: the flapper was not locked open and the flapper could open wide enough to install the insert safety valve. By performing this diagnostic imaging before beginning the intervention on the DHSV, the operator was able to eliminate other time-consuming and risky options, such as recompleting the well or attempting to mill the flapper. Instead, they were able to success-

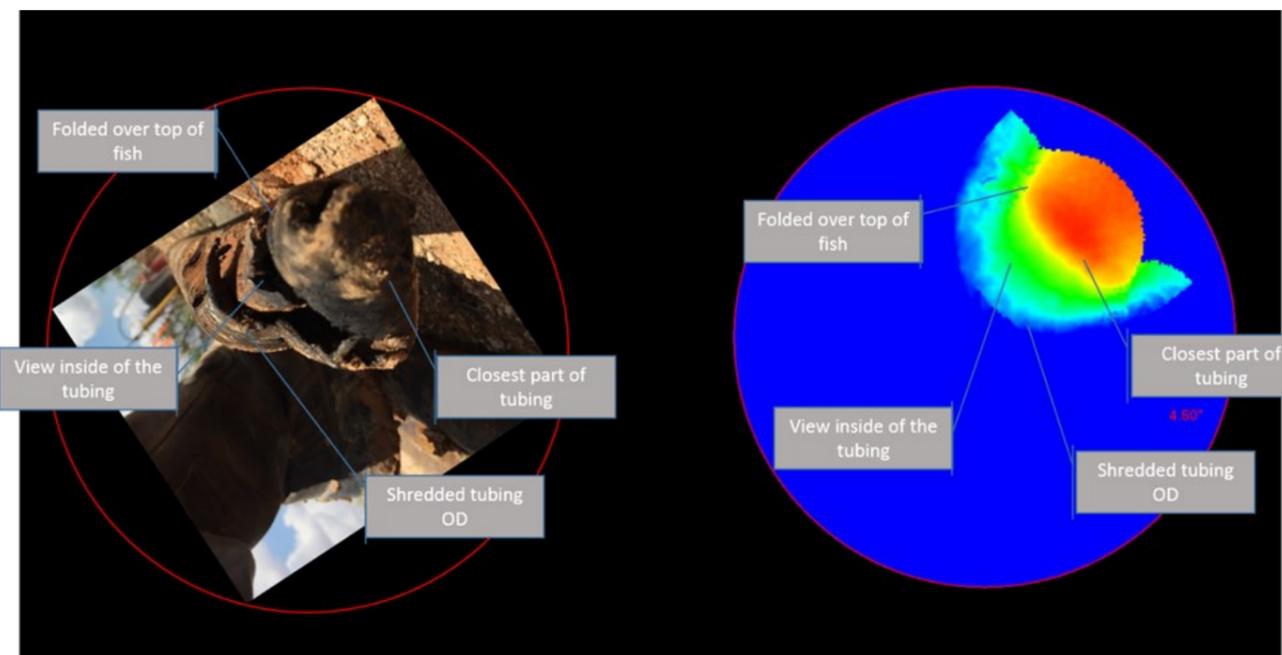
Figure 3. Results of VR90 service's X-ray investigation of parted tubing in Permian Basin (right) and photo of actual tubing pulled from well (left)

We achieved these objectives by tagging the top of the tubing and then acquiring multiple images above and below the top. One of the resulting images is shown in Figure 3 along with a photograph of the stuck tubing after it was fished from the well. The image reveals that the tubing had been slightly crushed against the casing producing an oval-shape at the top. Additionally, a sharp edge became folded over the top of the tubing blocking the inside of the tubing. The images also revealed damage along the tubing as no clear outer diameter was visible.

against further milling attempts and suggested a specific type of fishing tool. The client chose to follow these recommendations and successfully fished the tubing on the first attempt. When the tubing was pulled from the well, the VR90 service's diagnosis was confirmed as the folded-over top and shredded outer diameter were clearly evident on the fished tubing top. This outstanding outcome was possible due to the dimensional-accuracy of the reconstructions and the quick, reliable results produced by the VR90 service.
